The Hammond House at Woodsdale

The Hammond House at Woodsdale *Continued 2*

The Restoration

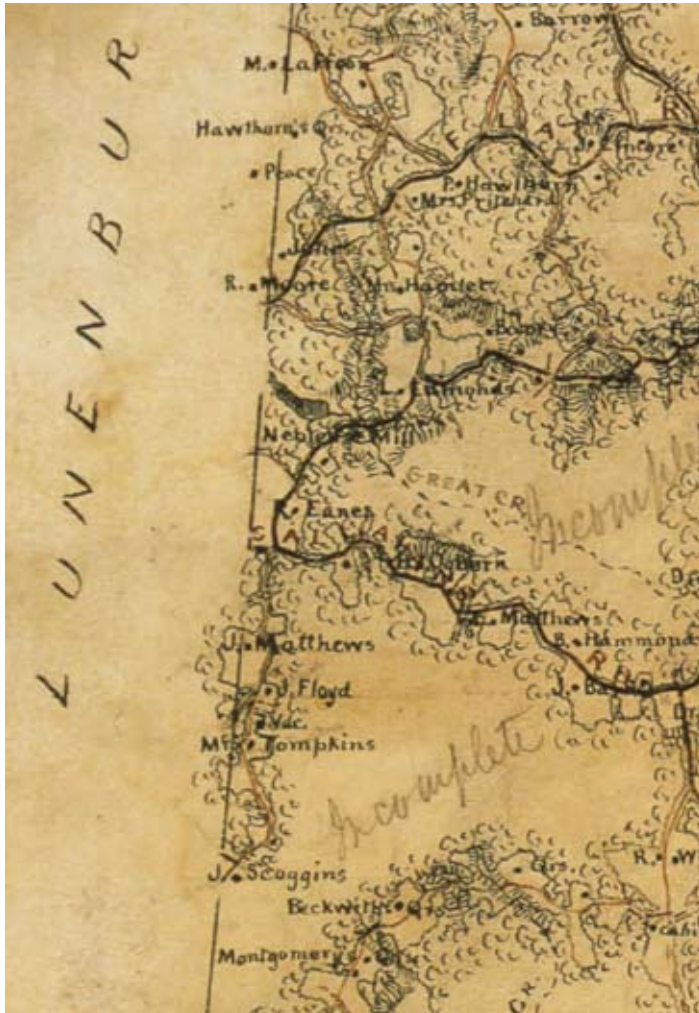
In various deeds, the road on which Woodsdale faces is named as Callahan’s or Callahum’s Road. In the map shown, courtesy of the Virginia Historical Society and the Town of Lawrenceville, Callahan’s Road is clearly marked. This map connects the dots on the various families that occur in the Hammond story — Matthews, Lafoon, Hawthorne,

Moore (Benjamin Hammond reported Moore's death in the Civil War), the post office at Edmund's store, and Great Creek. When this map was published the great Sturdivant Plantation had changed owners. It is not known why the

plantation is not shown. Note: The 1750s Plantation has been restored and its grounds updated. It is the home of the Richardson's from Richmond, Virginia. The Hammond House can be found easily on the map as B. Hammond, next door to and across the road from Matthews' properties.

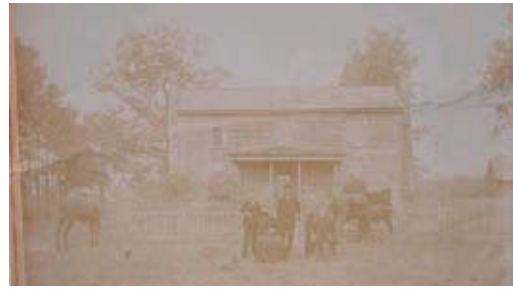
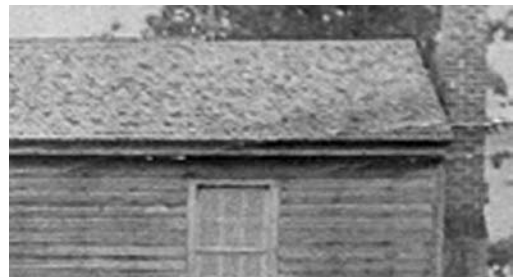
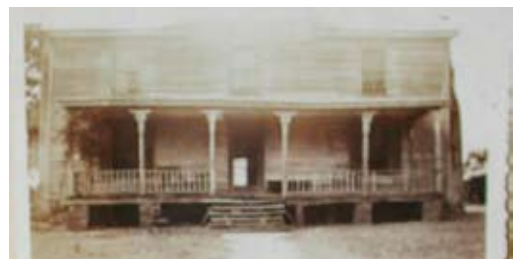
Pegged sill section removed during east/front sill replacement. Note difference in style from rear pegged sill (above).

Pictograph found under house in sill replacement process.

With the experts who have assisted we believe it is safe to say that the property was built in stages beginning pre-1800 with a two-level room-on-room cabin. Perhaps what we call the center room was even earlier. About 1800 the two-room house was expanded to a four-room house with central hall and stairway. What is not known is when the “center room” was connected to the expanded house; we think during the Victorian additions. The remains of the early outdoor stone 12' x 12' kitchen remain in the backyard. In approximately 1860 style overcame good sense and the house was expanded again with a Victorian porch across the front and a peak put in the roof. This peak has now been removed, a process necessary to protect the property from drainage it created. The process proved without doubt that the peak and porch were added — and not added well. We have required that materials that match the period be used for replaced sills,

woodwork and stone repairs. In fact, the original stone in the foundation was removed and re-placed in the foundation stabilizing process. Running concrete footers were added to support the replaced stone foundation. The only modern materials are the windows, drywall and architectural roofing shingles.

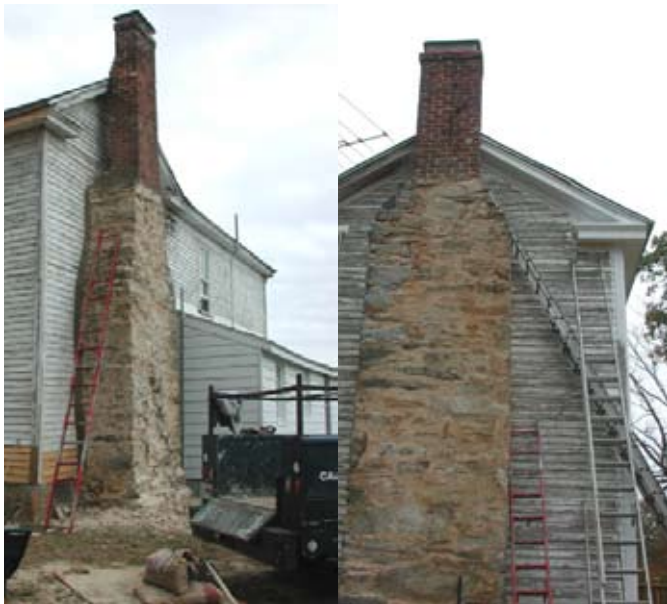
Left: East Chimney during restoration; Right: West Chimney during restoration.

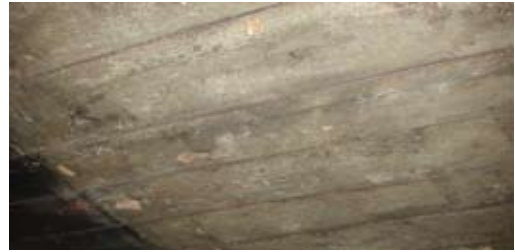
Rare wood ceiling in current kitchen. Identification assistance from photos sent to Department of Historical Resources, Virginia and U.S. Department of Forestry. Preservation by both entities was suggested.

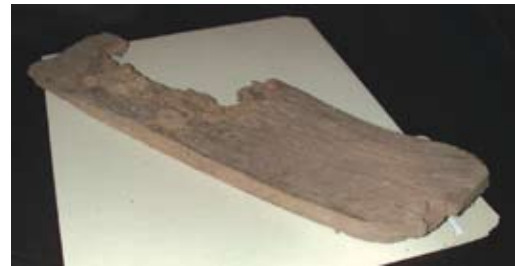
Early hewn roof shingle found under house in dirt.

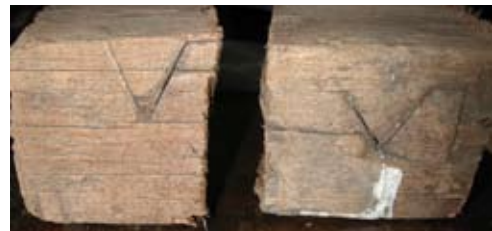
Numbered stud sections removed to level front wall to replacement sill. Colonial Williamsburg commented that the method of Roman numbering with the connected numerals was unusual. It occurs again on the fireplace wall.
